1. AGENCY USE ONLY (Leave blank)	2. REPORT DATE 1996	3. REPORT TYPE AND DATES COVERED Final Report		
4. TITLE AND SUBTITLE The Old Hospital Complex (5EP1778) Fort Carson, Colorado		5. FUNDING NUMBERS

13. ABSTRACT (Maximum 200 words) <p>The Old Hospital Complex (5EP1778) at Fort Carson, Colorado, consists of 59 buildings. The Complex was built during World War II and is significant due to its association with the history of the United States. The complex is semi-permanent construction, constructed from the Department of the Army's Series 800 plans. This report documents the complex in accordance with Section 1(g) of the Memorandum of Agreement enacted among the Department of the Army, Headquarters Fort Carson, the Colorado State Historic Preservation Office, and the Advisory Council on Historic Preservation.</p> <p style="text-align: center;">DTIC QUALITY INSPECTED 2</p>

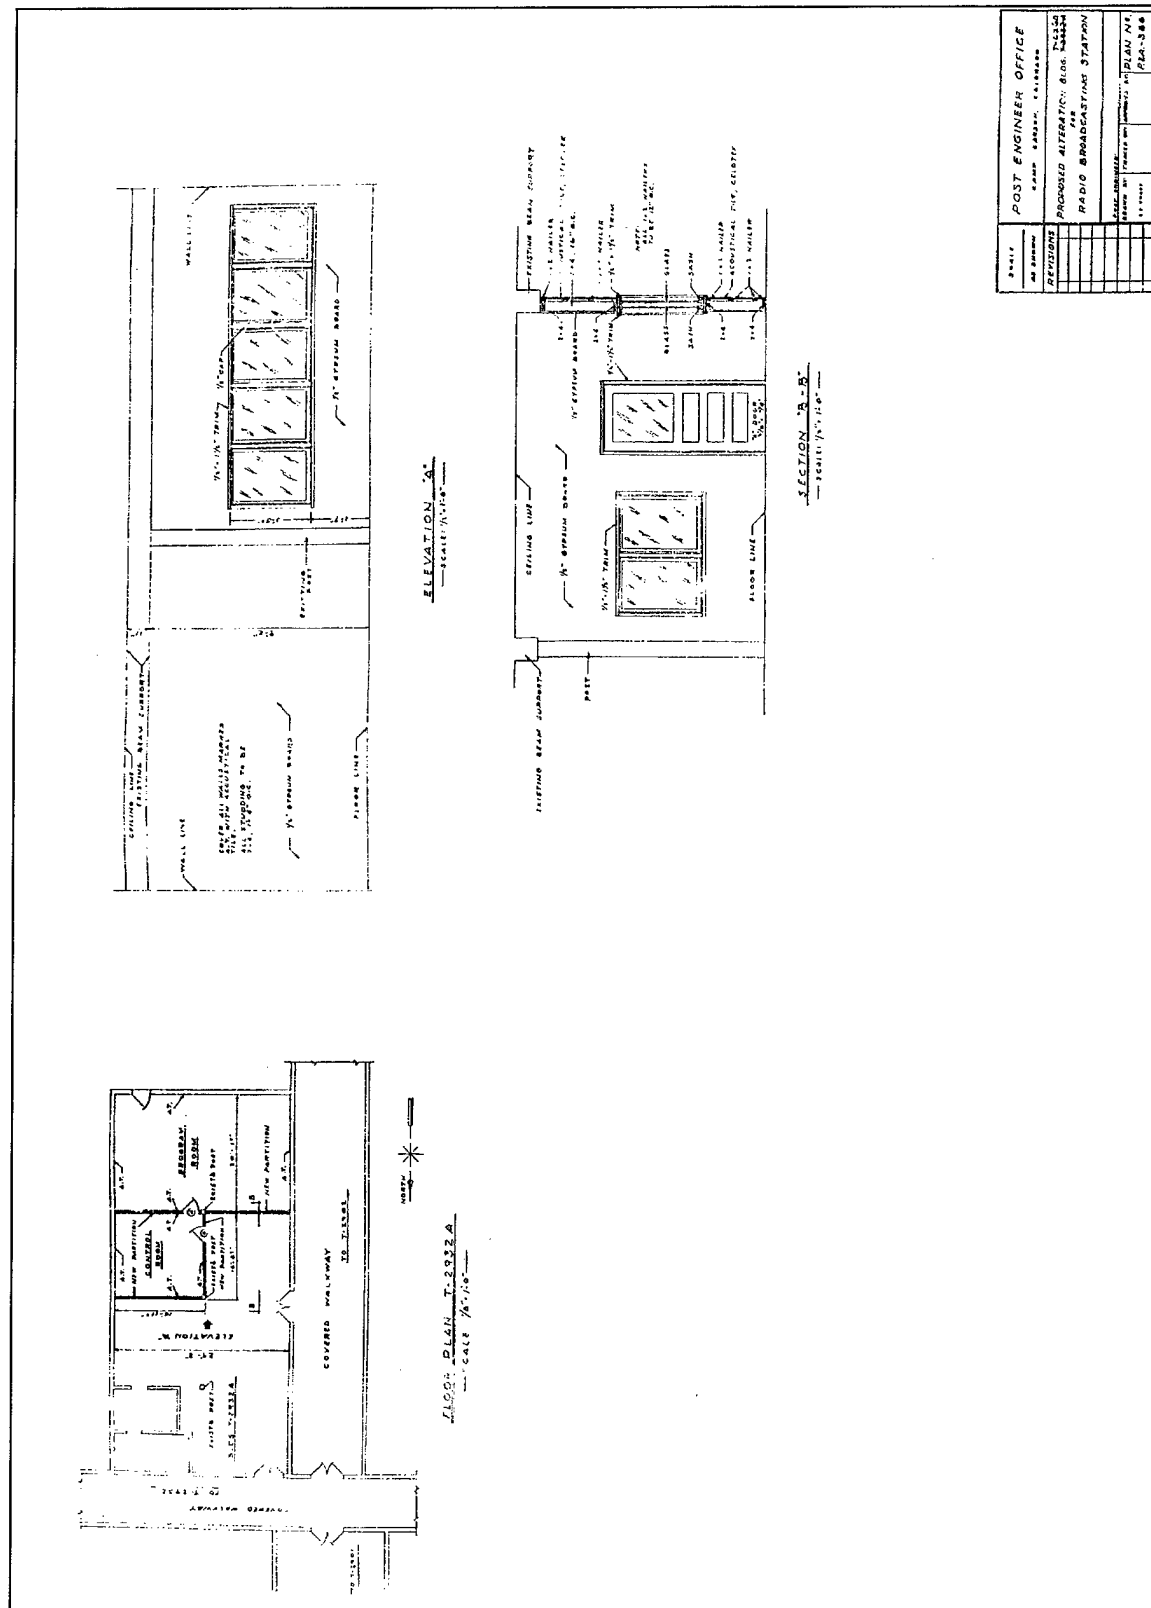
Figure V.238 5EP1778. Proposed alterations for Building S6260, Radio Broadcasting Station, PEA Series, Sheet 386.

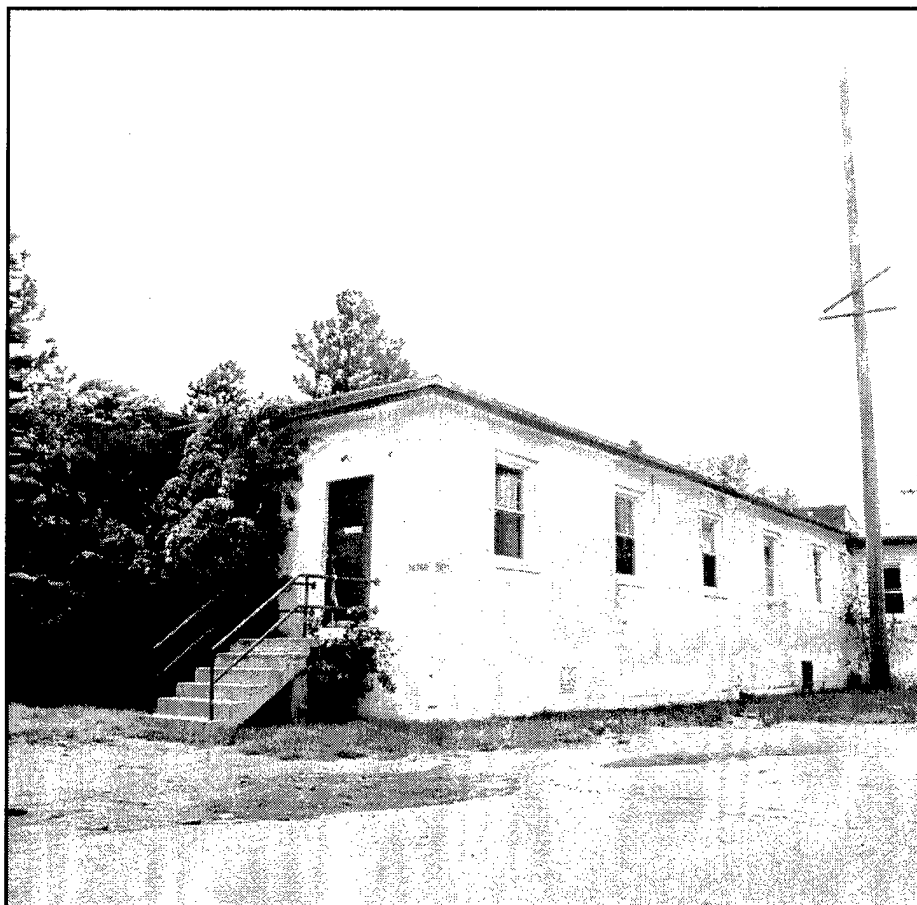
Figure V.239 5EP1778. Building S6260, Radio Broadcasting Station. Three-quarter view of south and east faces. Roll 4H, Exposure 11.

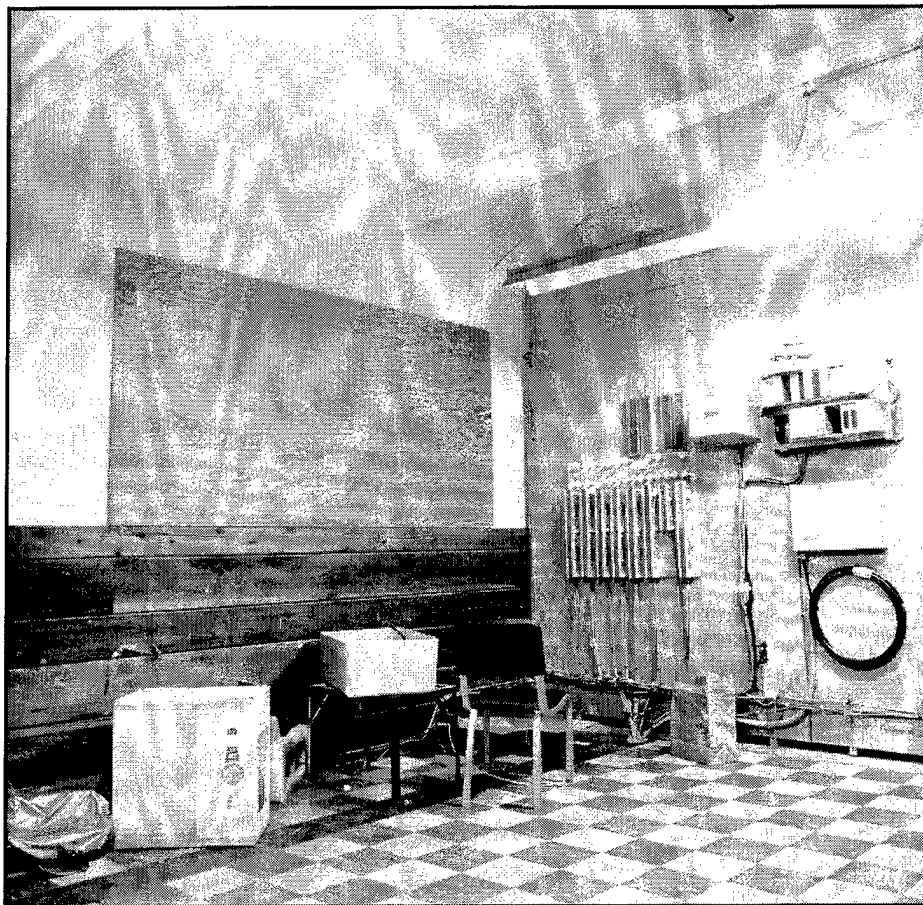
Figure V.240 5EP1778. Building S6260, Radio Broadcasting Station. Interior shot of wall and ceiling tiles. View from southeast. Roll 4H, Exposure 4.

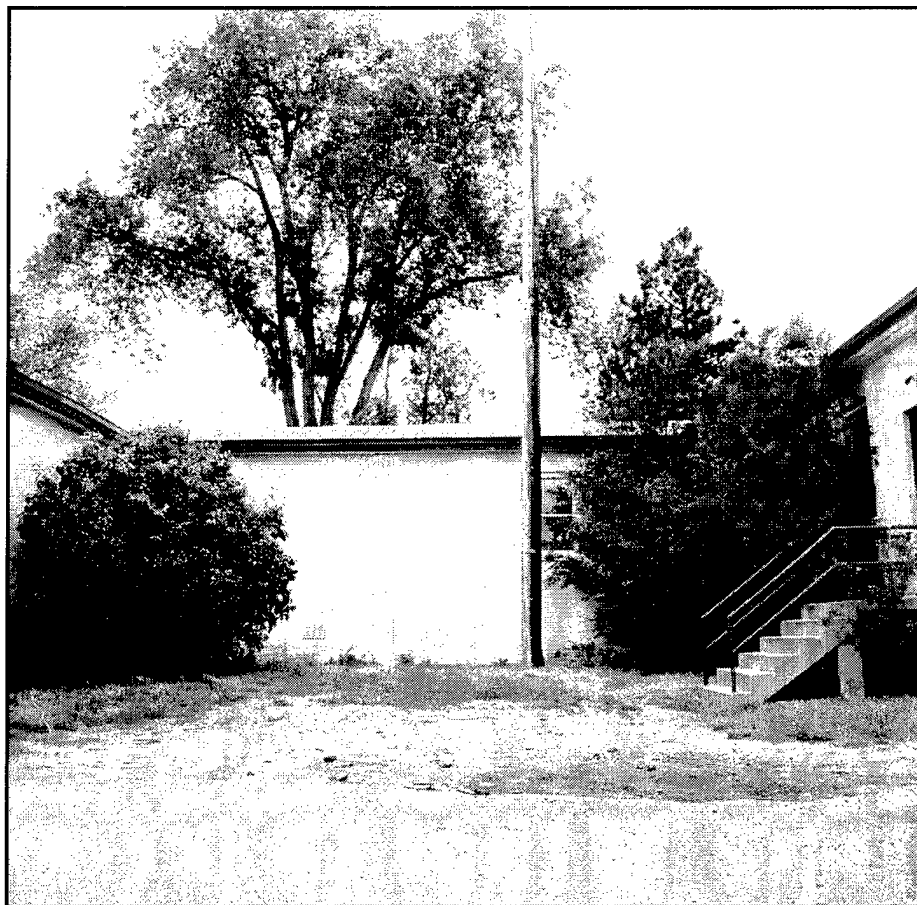
Figure V.241 5EP1778. East face of corridor connecting Buildings S6260 and S6250. 800 Series, Type H.C.WK.-B. Roll 5H, Exposure 3.

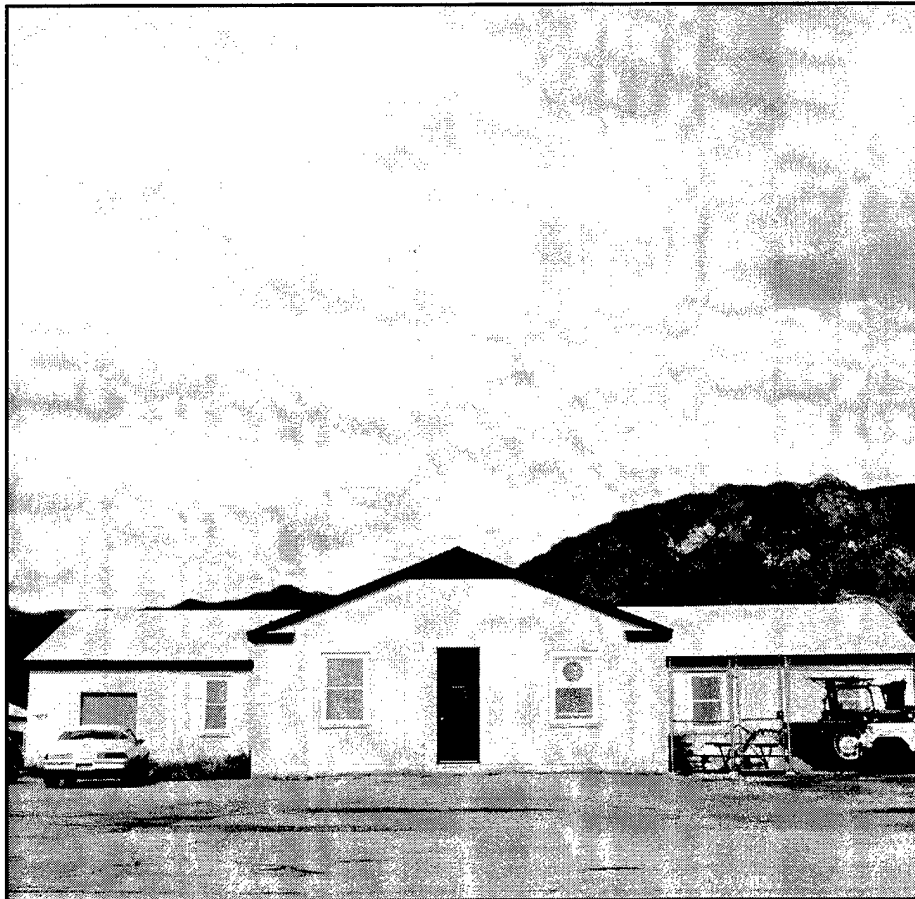
Figure V.243 5EP1778. Building S6274, Shop, 800 Series, Type HSH-1. East face. Roll 9F, Exposure 2.

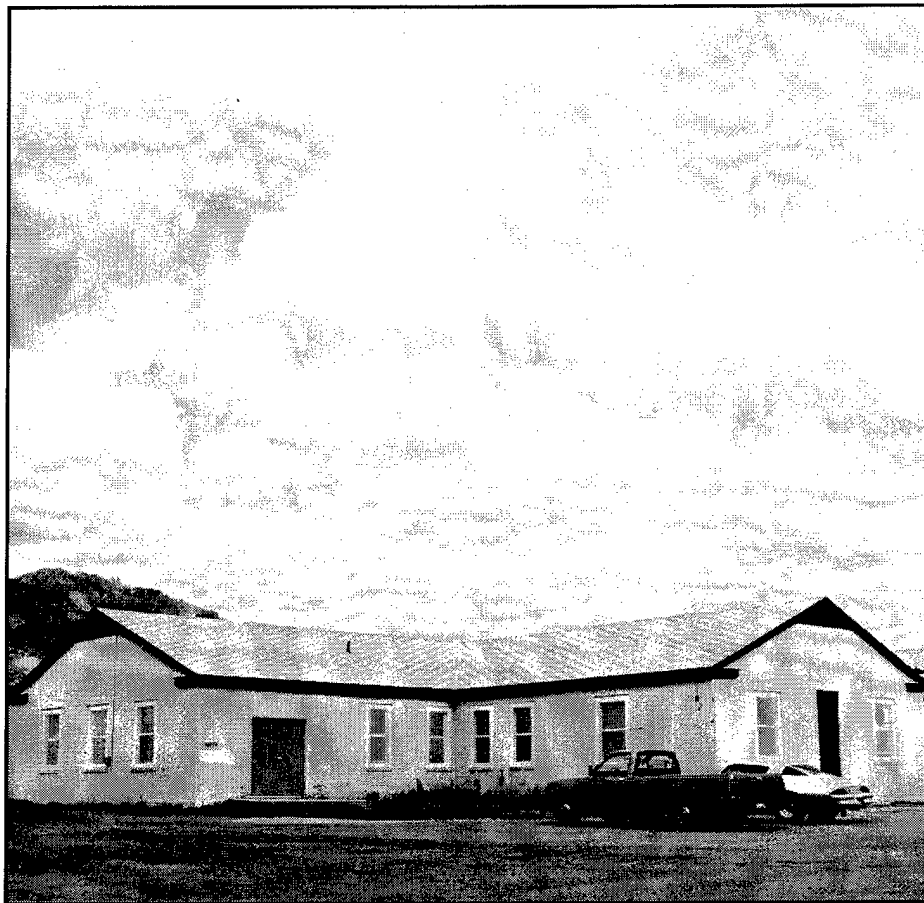
Figure V.244 5EP1778. Building S6274, Shop, 800 Series, Type HSH-1. Three-quarter view of east and south faces. Roll 9F, Exposure 6.

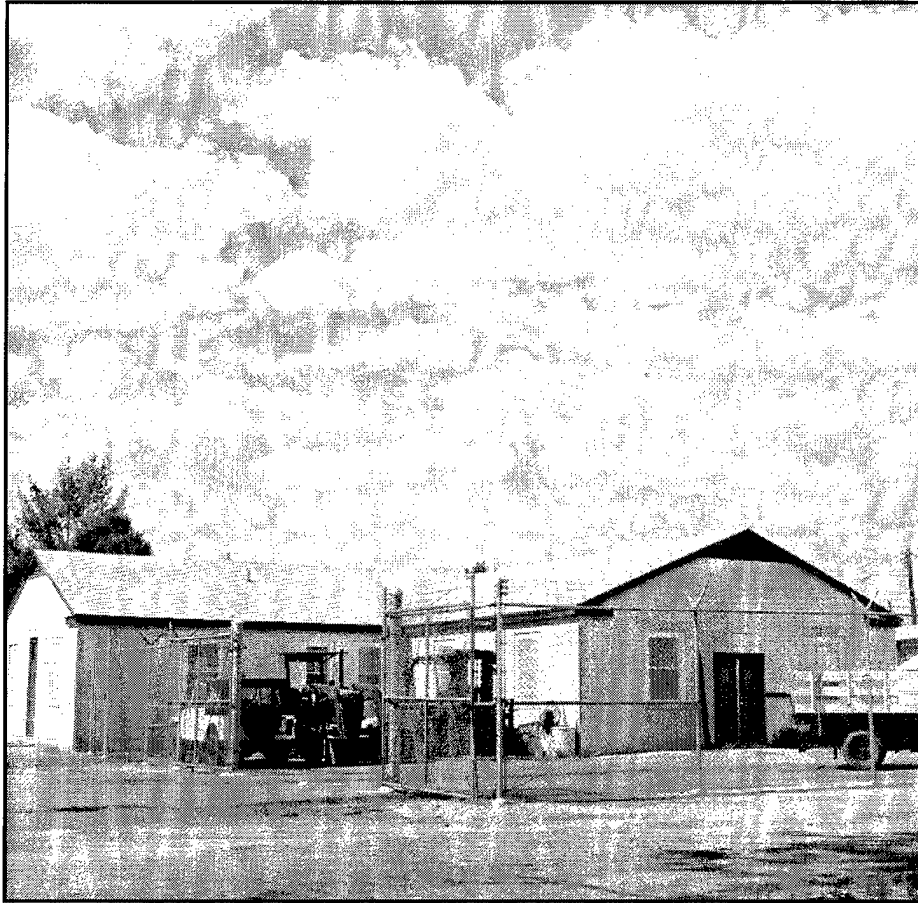
Figure V.245 5EP1778. Building S6274, Shop, 800 Series, Type HSH-1. Three-quarter view of north and east faces. Roll 8F, Exposure 11.

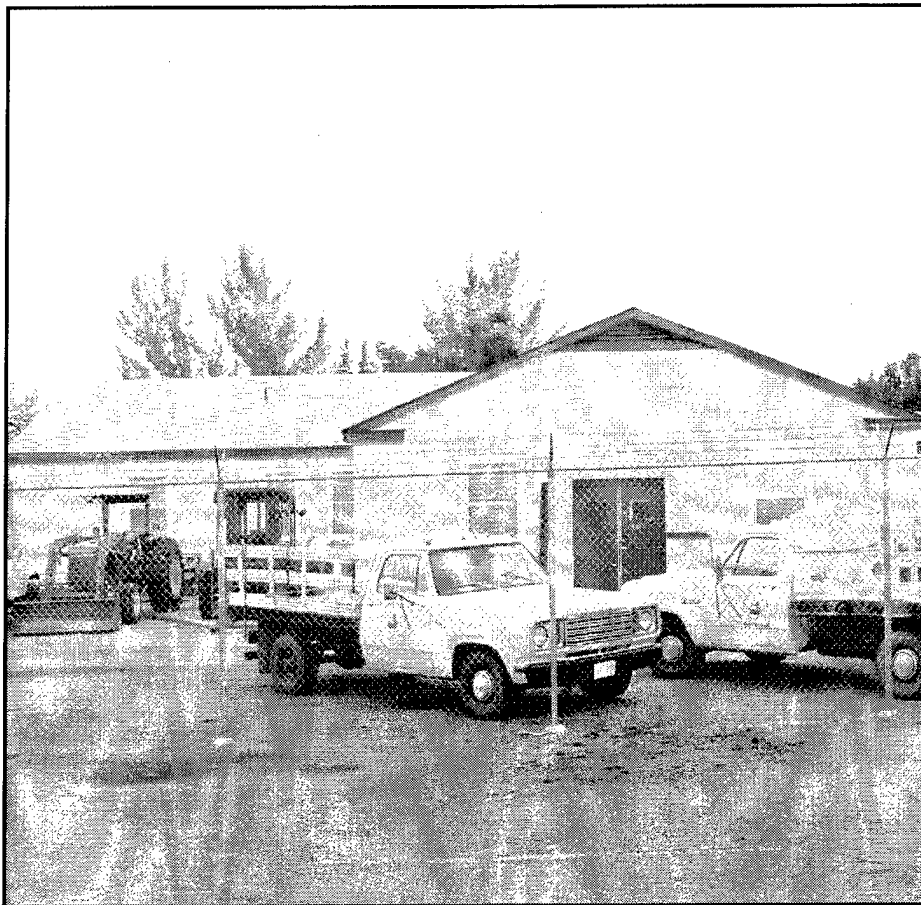
Figure V.246 5EP1778. Building S6274, Shop, 800 Series, Type HSH-1. North face. Roll 13F, Exposure 9.

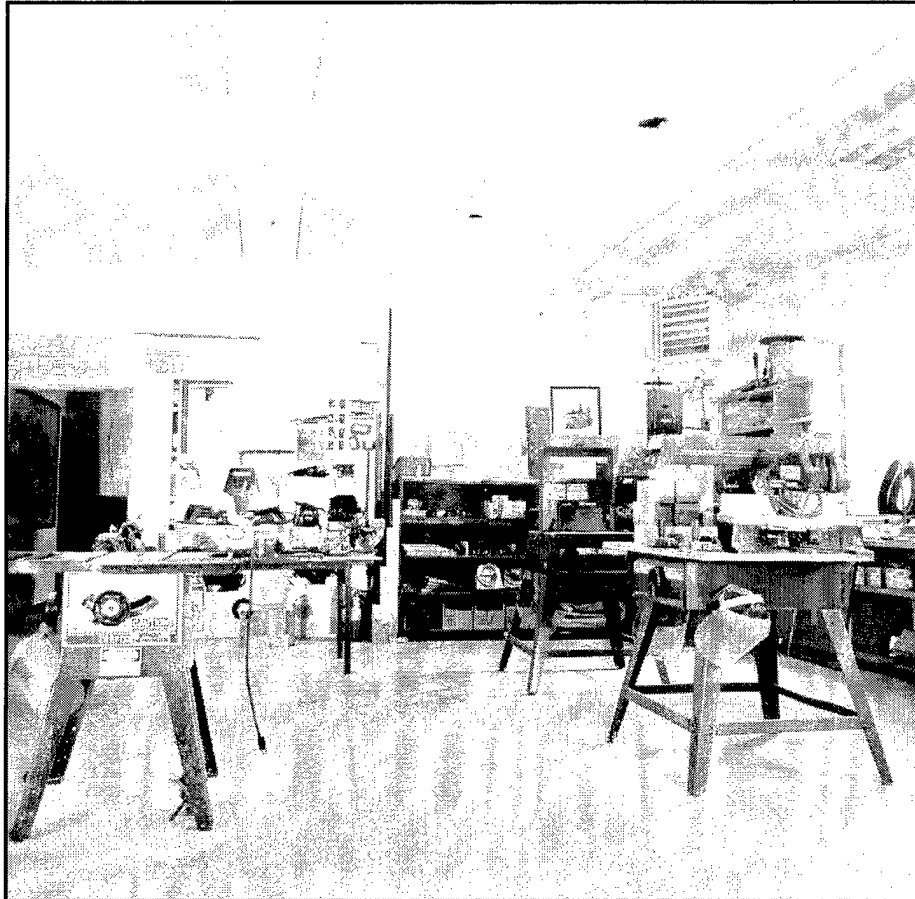
Figure V.247 5EP1778. Building S6274, Shop. 800 Series, Type HSH-1. Interior shot of workshop, viewed from north entrance of building, facing southwest. Roll 2F, Exposure 10.

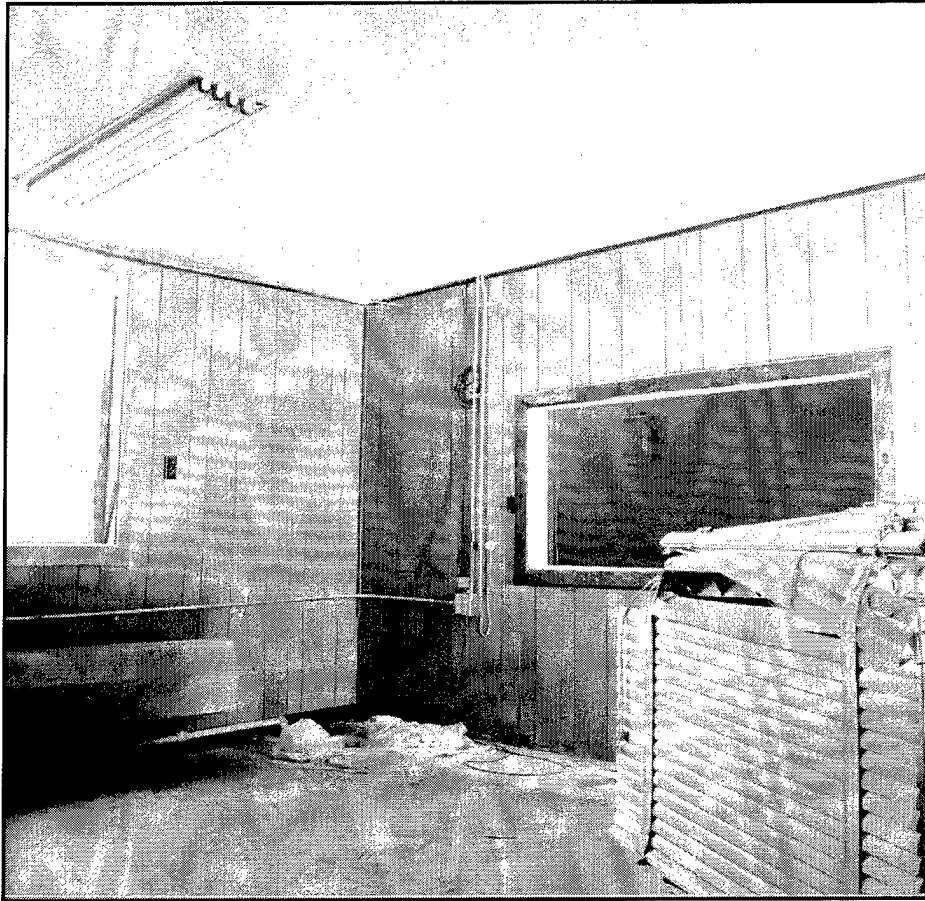
Figure V.248 5EP1778. Building S6274, Shop, 800 Series, Type HSH-1. Interior shot of west side office with reception window, viewed from southeast corner. Roll 3F, Exposure 8.

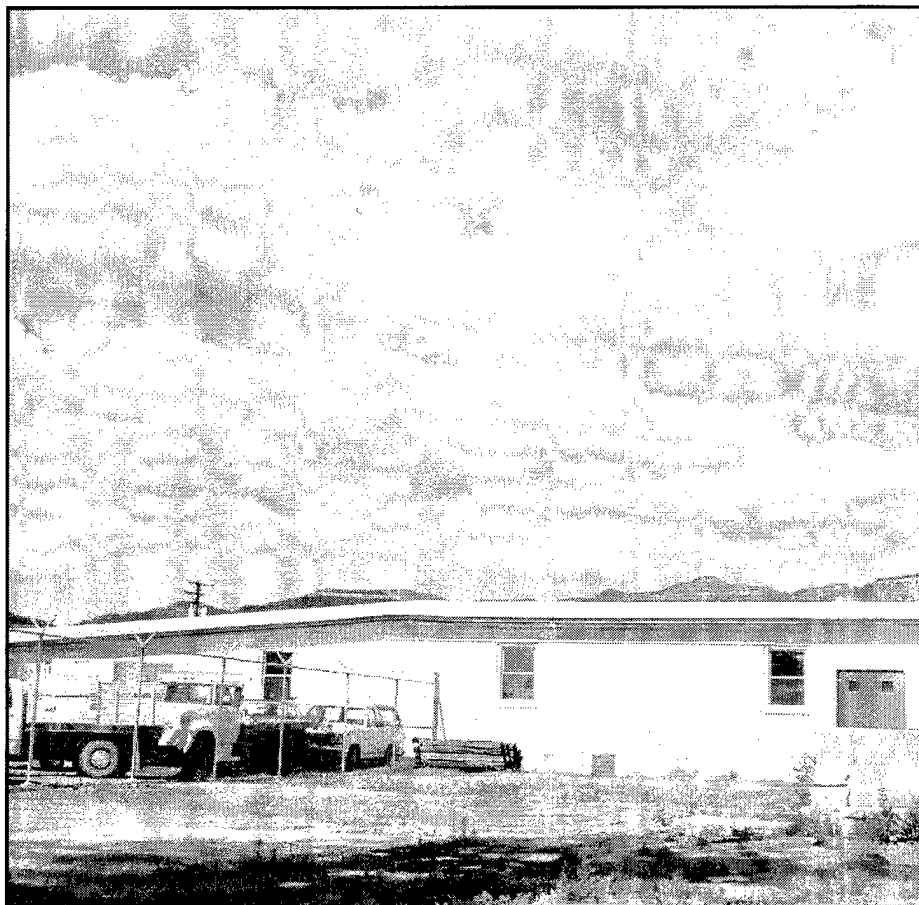
Figure V.249 5EP1778. East face of corridor connecting Buildings S6274 and S6273 to Building S6271. 800 Series, Type H.C.WK.-A1. Roll 8F, Exposure 8.

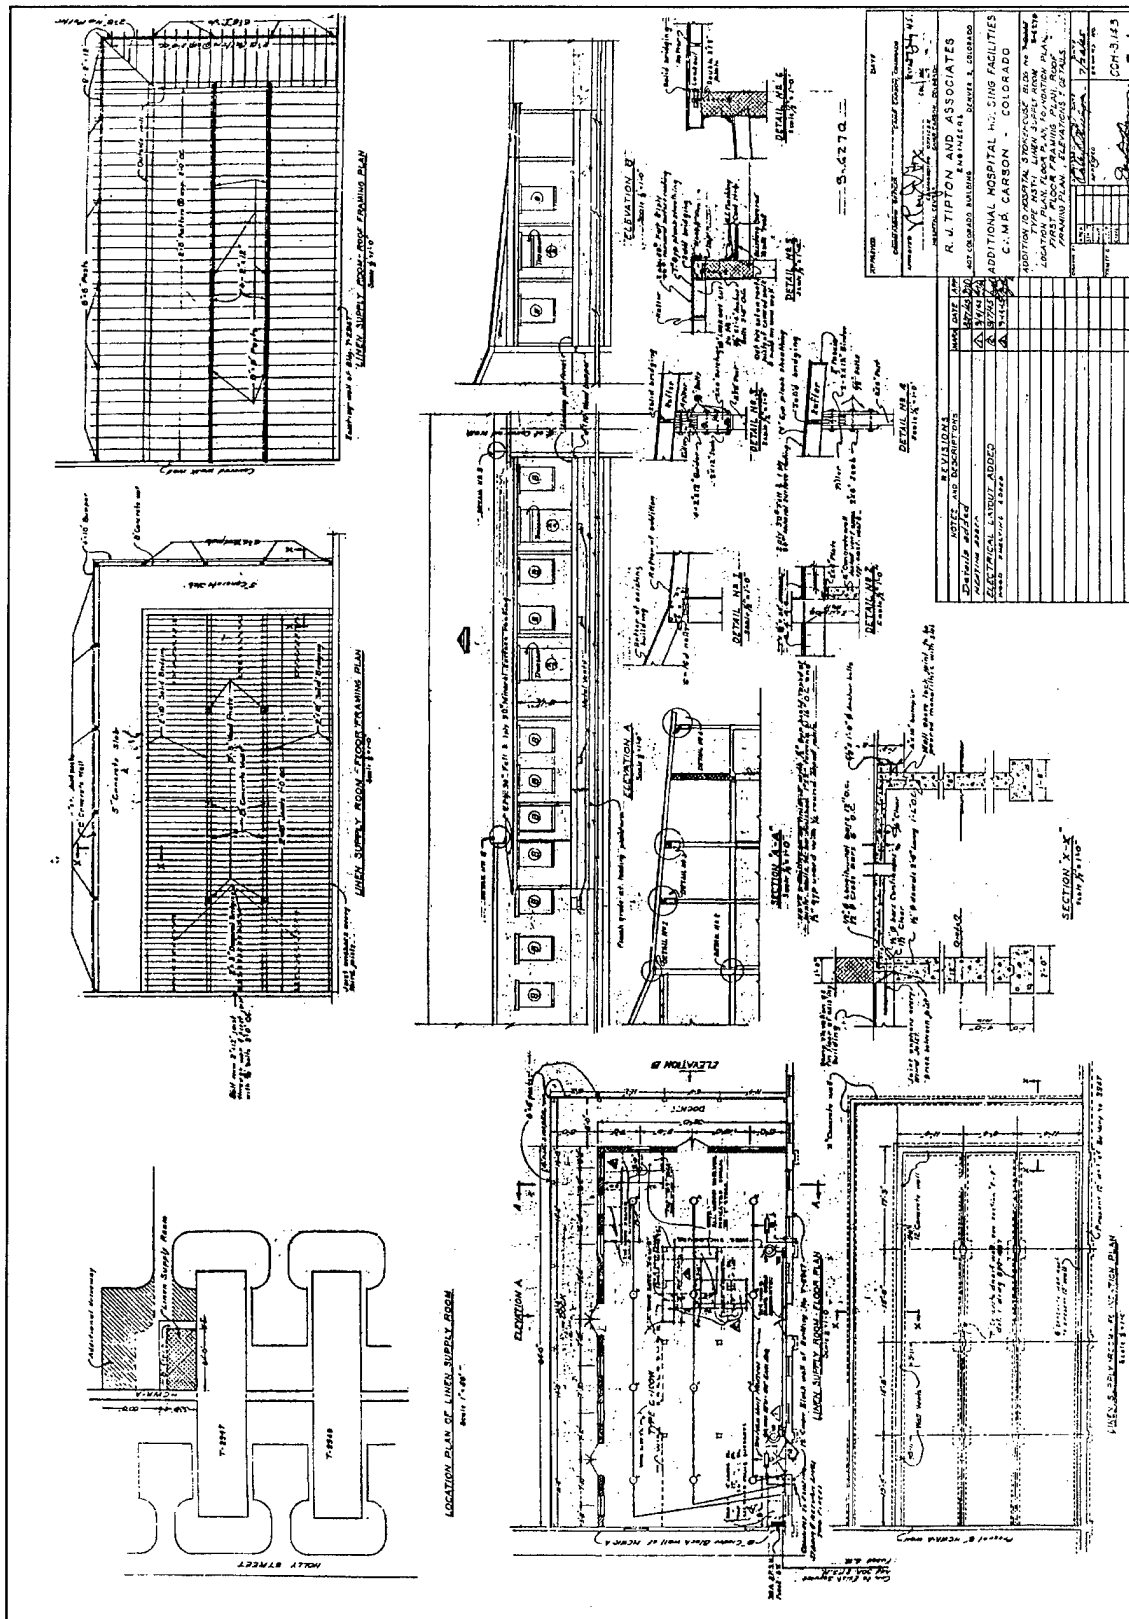
Figure V.251 5EP1778. Addition to Building S6270, Type HST-1, Linen Supply Room, CSA Series, Plan 3.143.

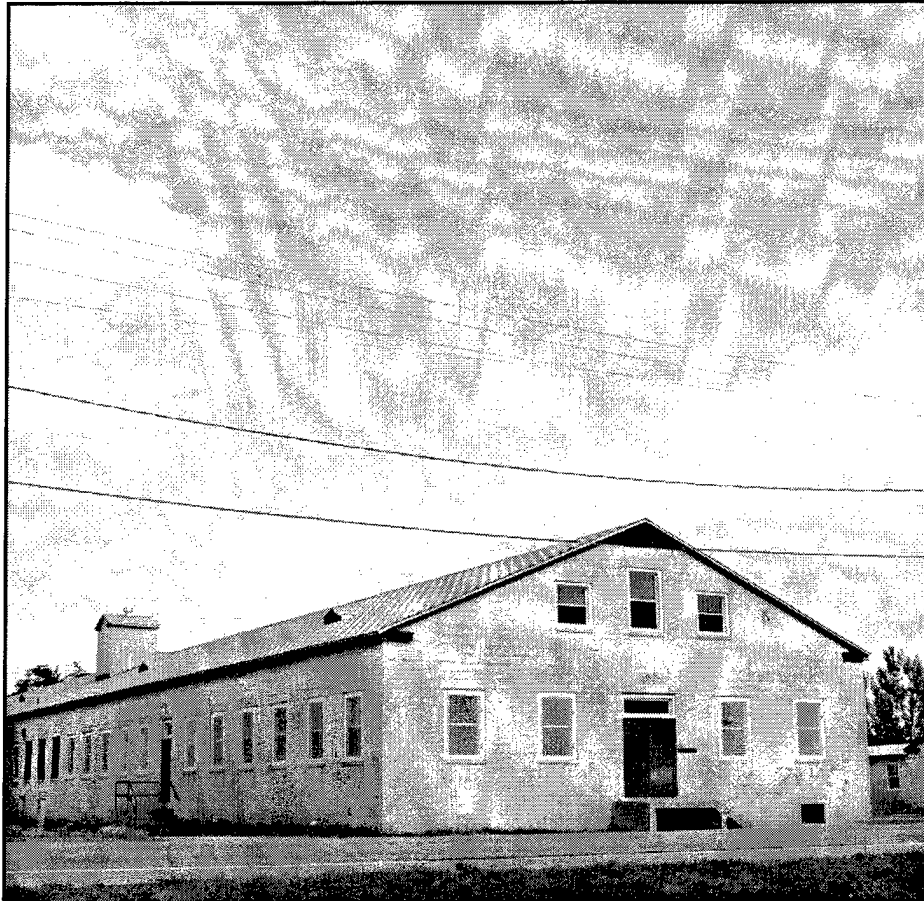
Figure V.252 5EP1778. Building S6270, Storehouse, 800 Series, Type HST-1. Three-quarter view of west wing's west and north face. Roll 15F, Exposure 10.

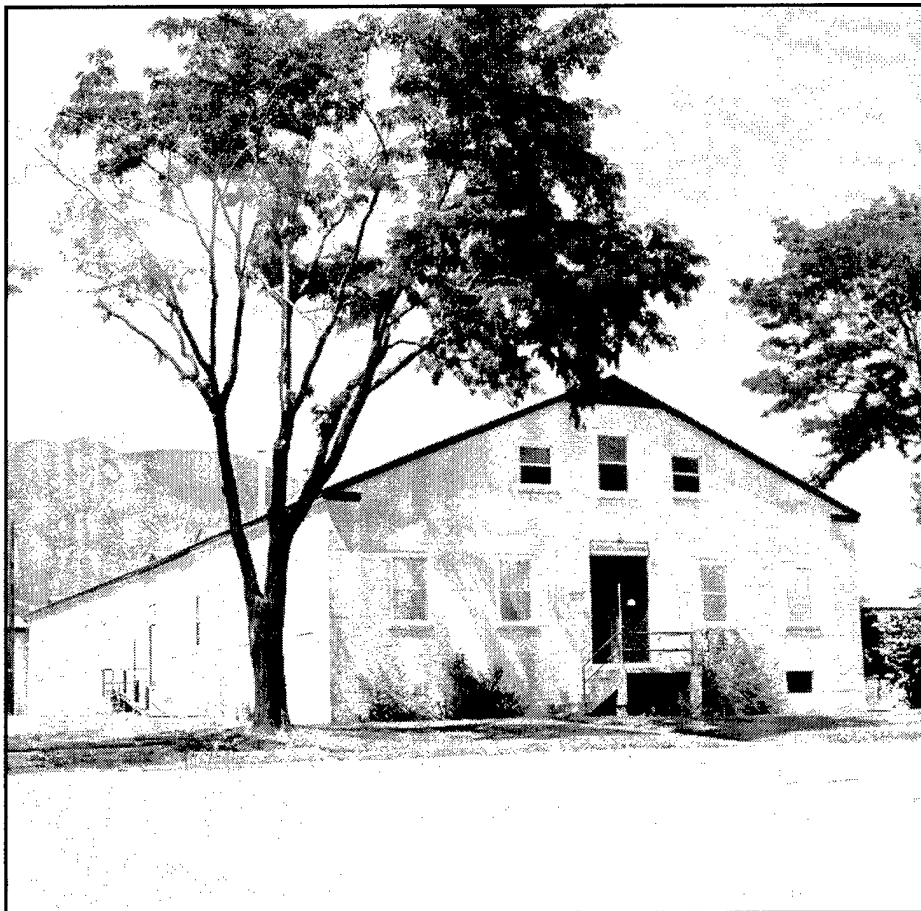
Figure V.253 5EP1778. Building S6270, Storehouse, 800 Series, Type HST-1. Three-quarter view of east wing's east and south face. Roll 15E, Exposure 4.

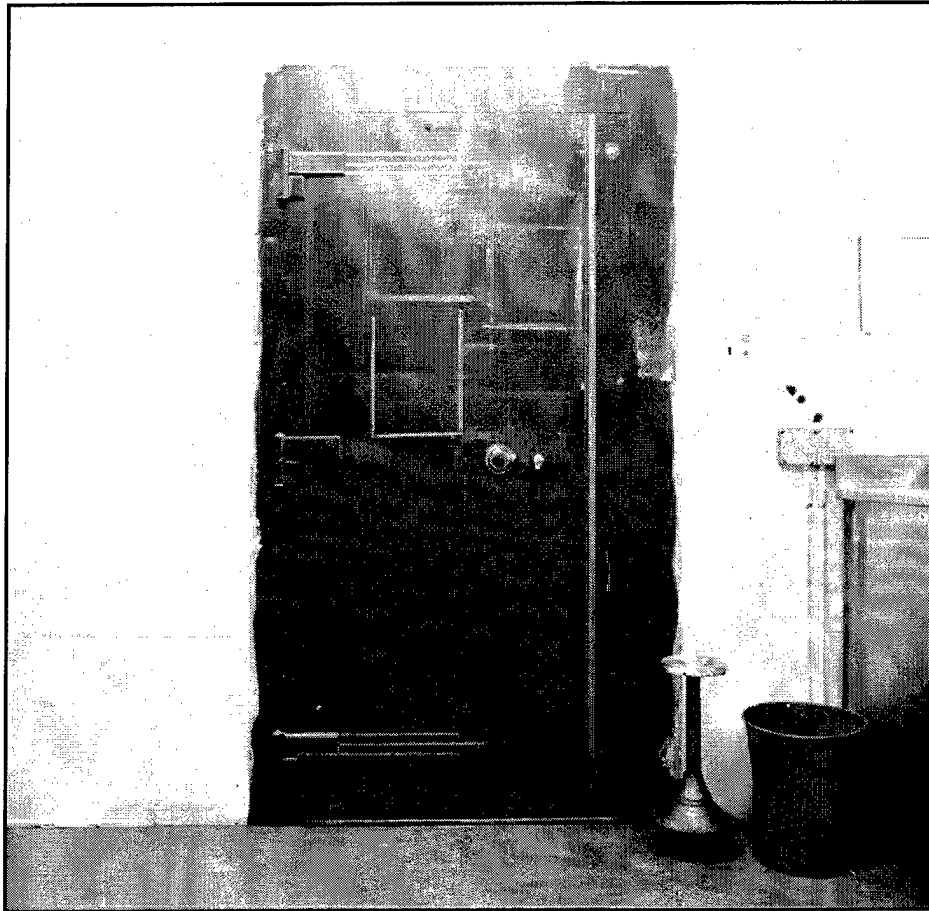
Figure V.254 5EP1778. Building S6270, Storehouse, 800 Series, Type HST-1. Interior shot of safe in Room 5, east side, ground floor. Roll 1F, Exposure 2.

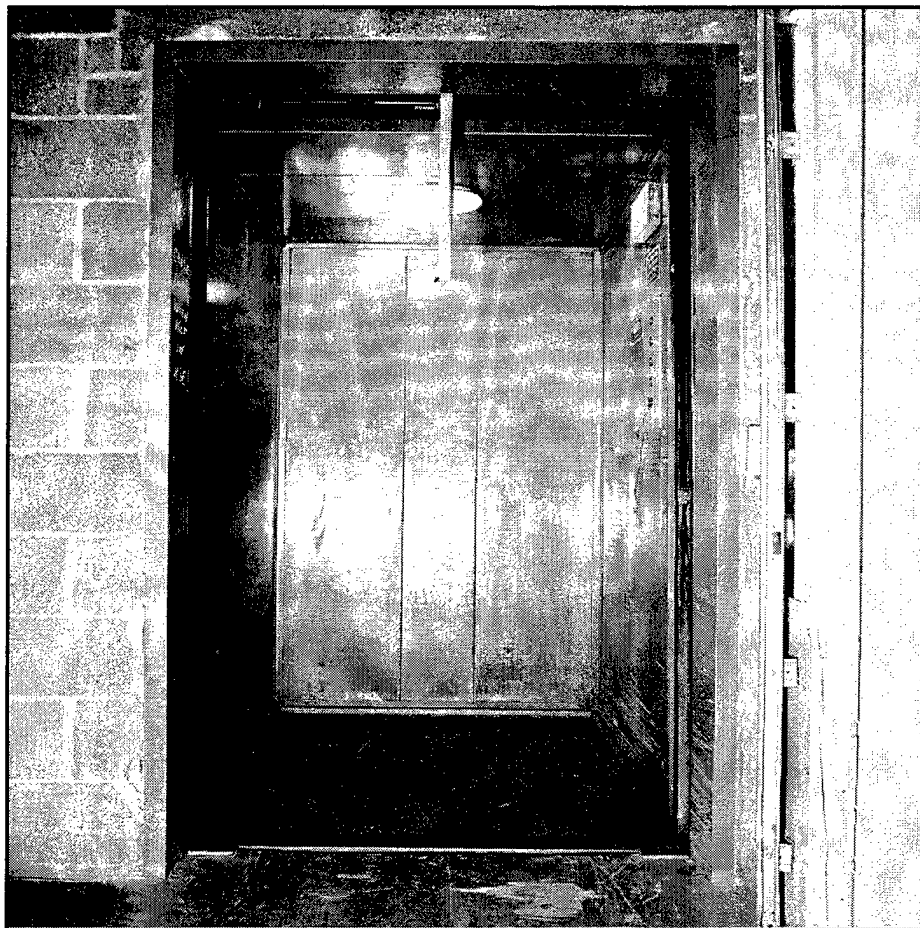
Figure V.255 5EP1778. Building S6270, Storehouse, 800 Series, Type HST-1. Interior shot of elevator, looking inside. Roll 1F, Exposure 8.

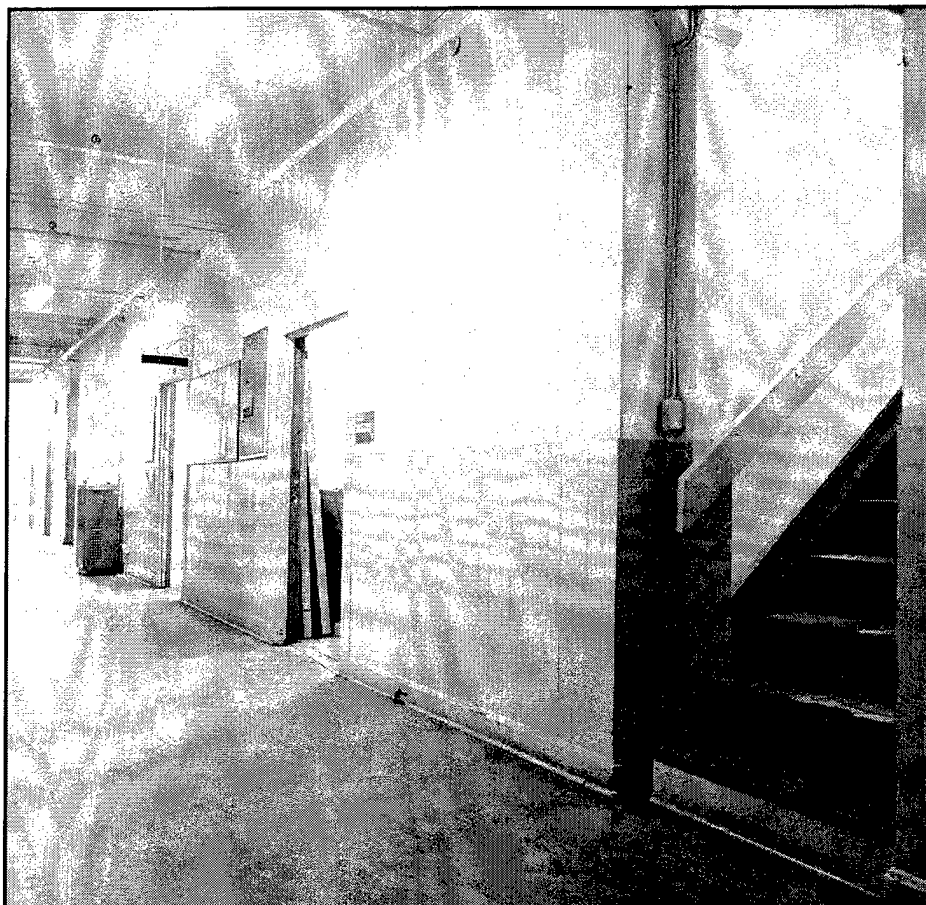
Figure V.256 5EP1778. Building S6270, Storehouse, 800 Series, Type HST-1. Interior shot of east side of hallway, with offices and enclosed staircases. Roll 1F, Exposure 6.

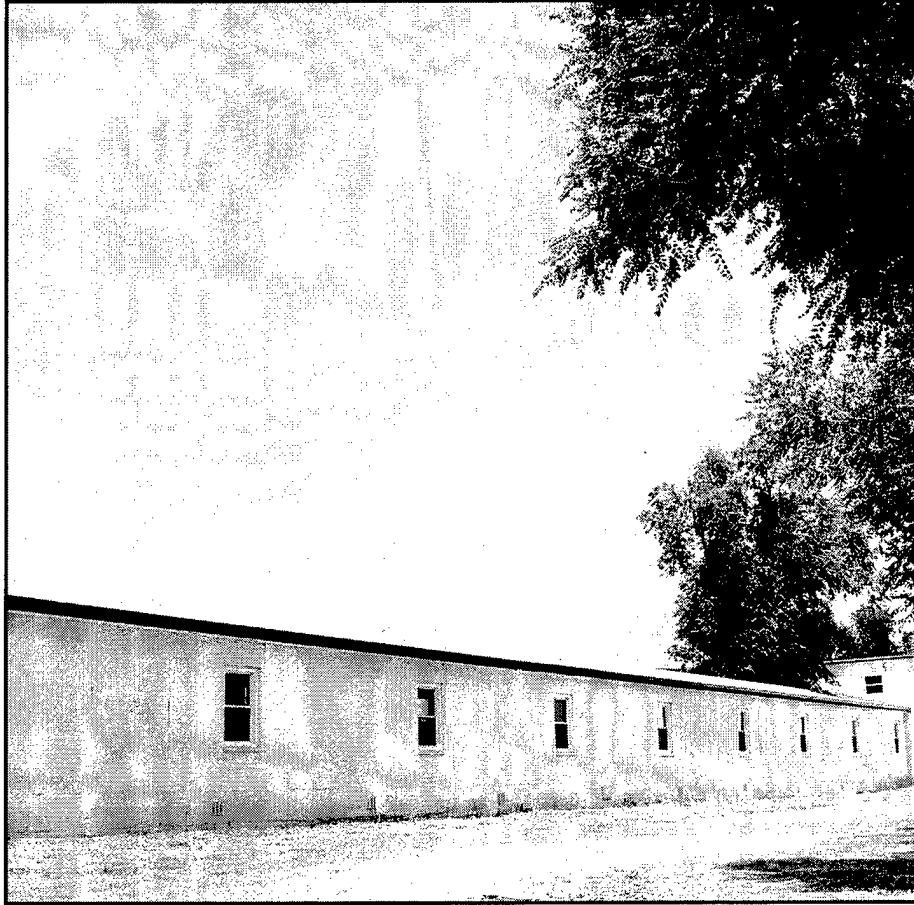
Figure V.257 5EP1778. East face of corridor connecting Building S6270 to east-west corridor between Buildings S6253 and S6252. 800 Series, Type H.C.WK.-A. Roll 15E, Exposure 7.

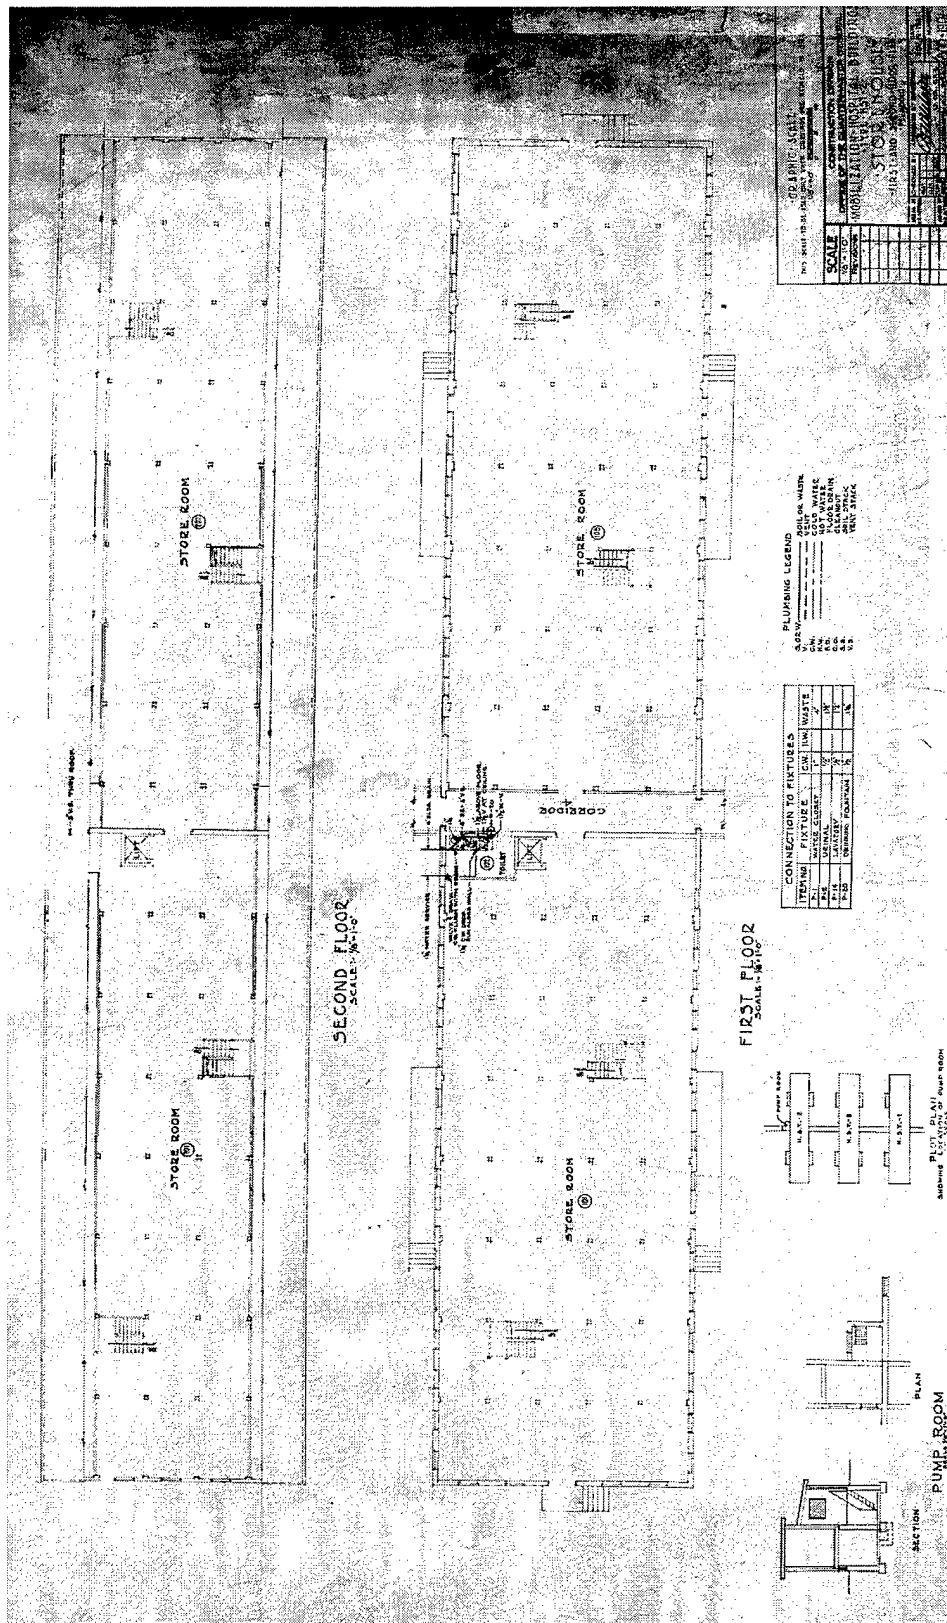
Figure V.258 SEP1778. First- and second-floor plumbing plans for Building S6271, Storehouse, 800 Series, Type HST-2, Plan 800-1901.

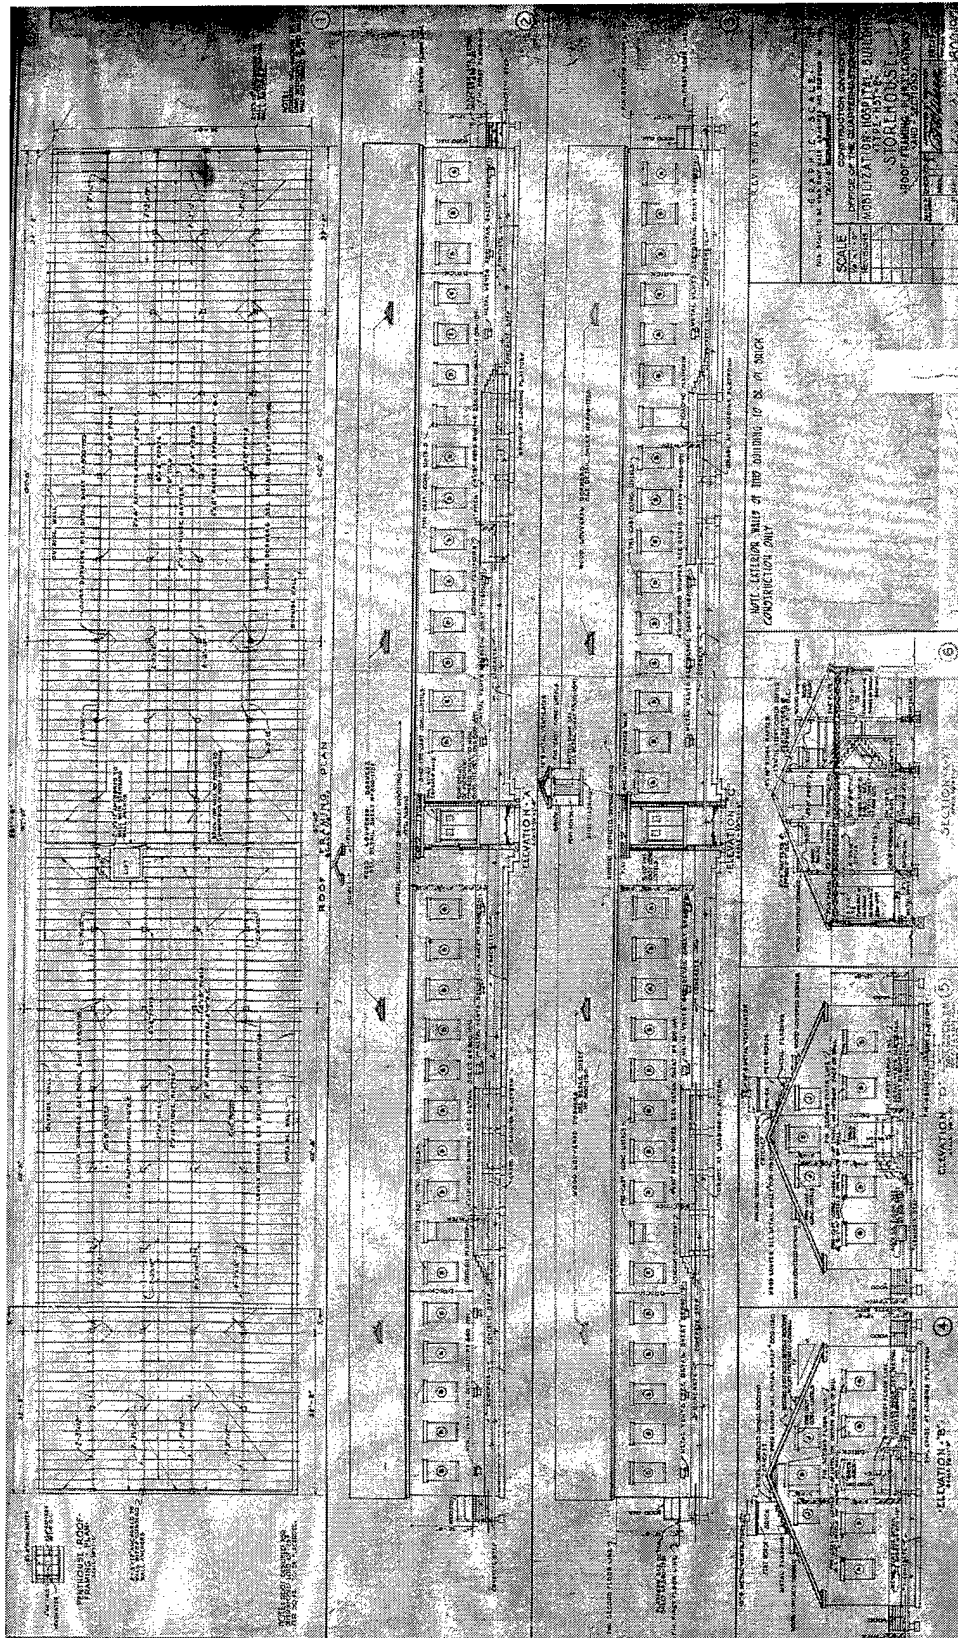
Figure V.259 5EP1778. Roof framing plans, elevations and sections for Building S6271, Storehouse, 800 Series, Type HST-2, Plan 800-1900.

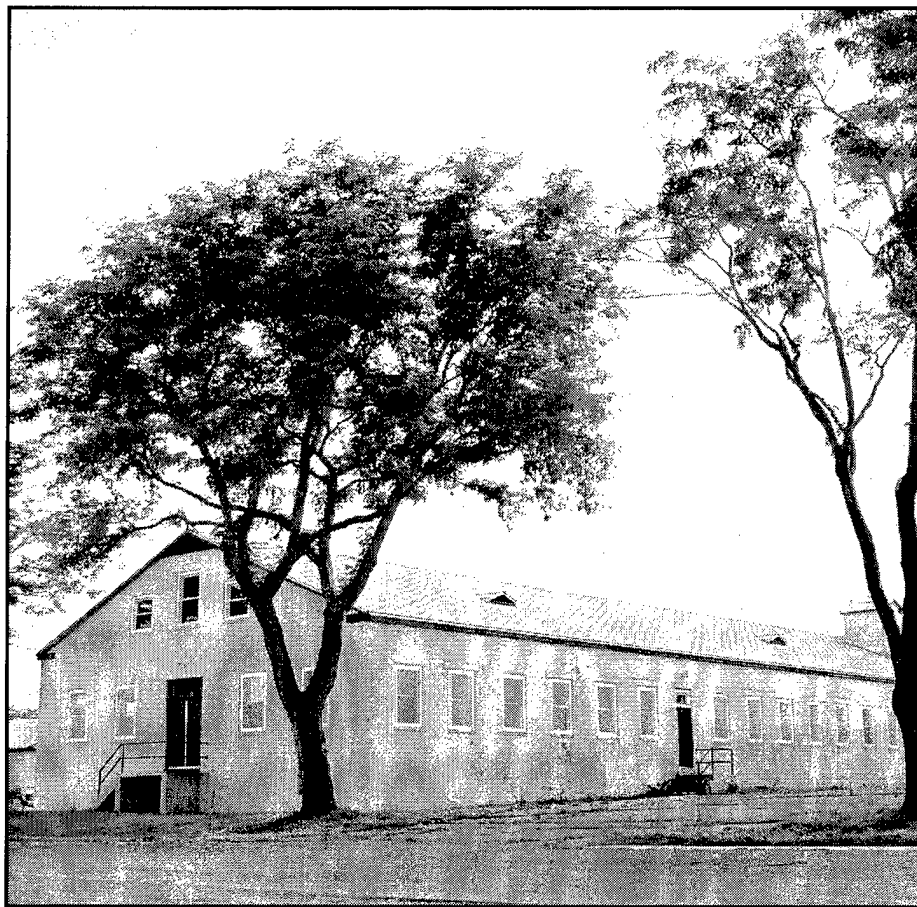
Figure V.260 5EP1778. Building S6271, Storehouse, 800 Series, Type HST-2. Three-quarter view of east wing's east and north face. Roll 16F, Exposure 1.

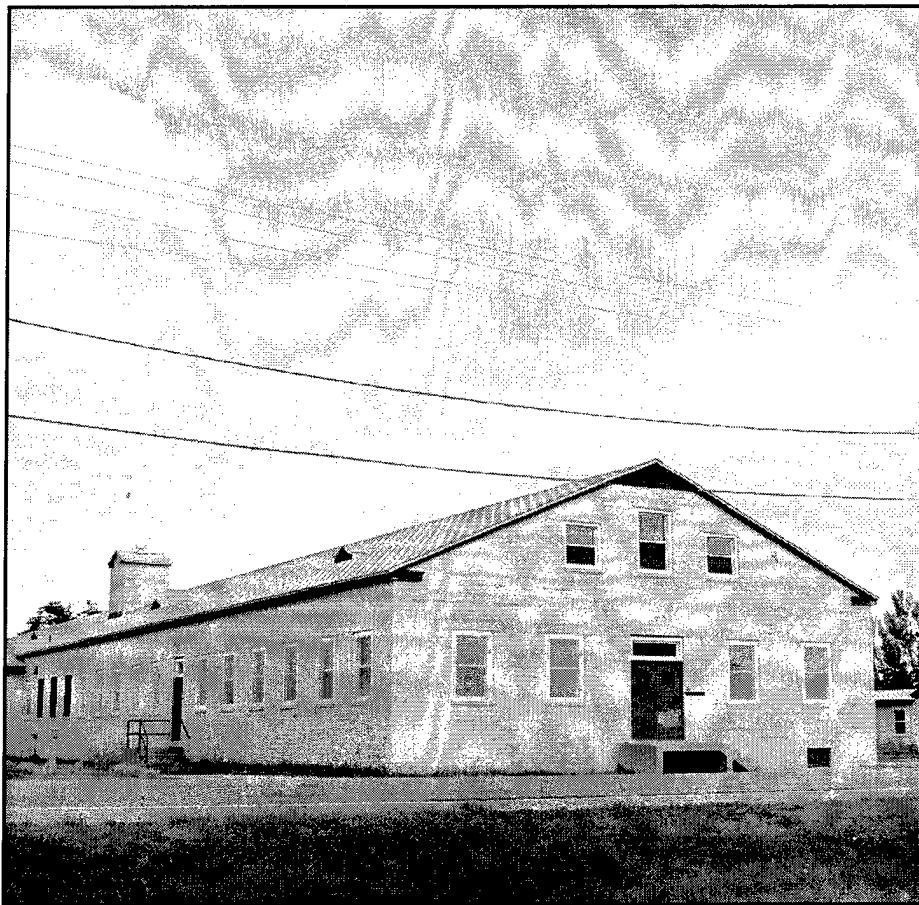
Figure V.261 5EP1778. Building S6271, Storehouse, 800 Series, Type HST-2. Three-quarter view of west wing's west and north face. Roll 15F, Exposure 9.
